NASA CR-145271

Flight Control Electronics Reliability/Maintenance Study

**Boeing Commercial Airplane Company
Seattle, Washington**

FLIGHT CONTROL ELECTRONICS RELIABILITY/MAINTENANCE STUDY

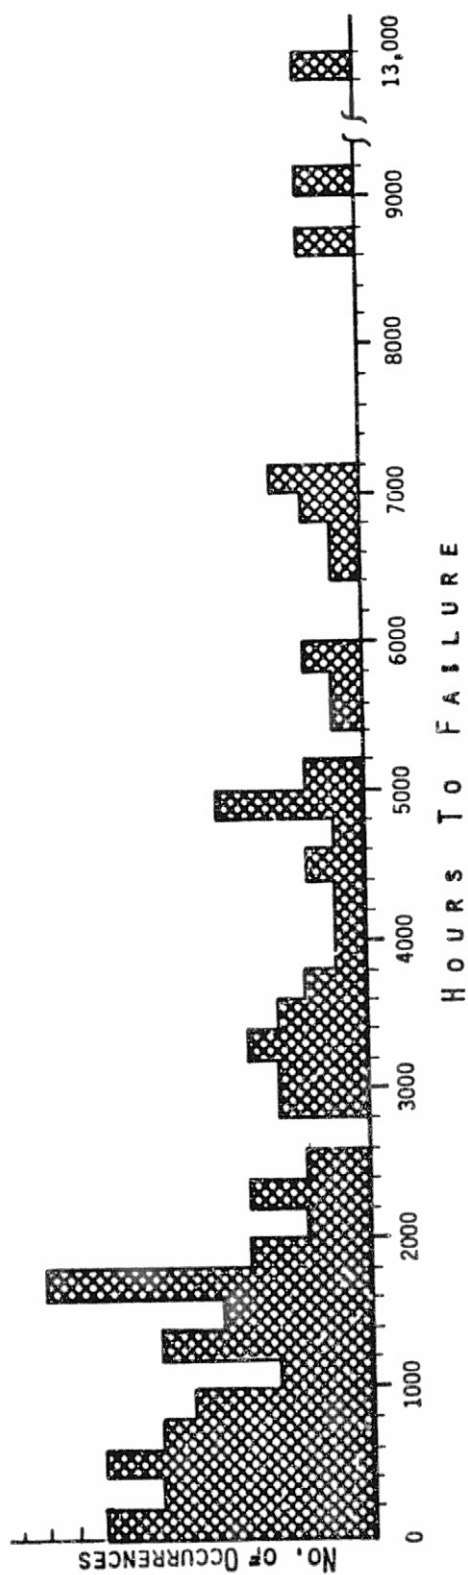
Figure 5-3.—Roll Computer Failure Time Distribution

- b) Failure Rate Characteristics — figure 5-3.

Performance Anomaly	25%
Failure/Warning Indication	9%
Fails BITE Test	38%
Inoperative	6%
Engage/Disengage Problem	17%
Other	5%

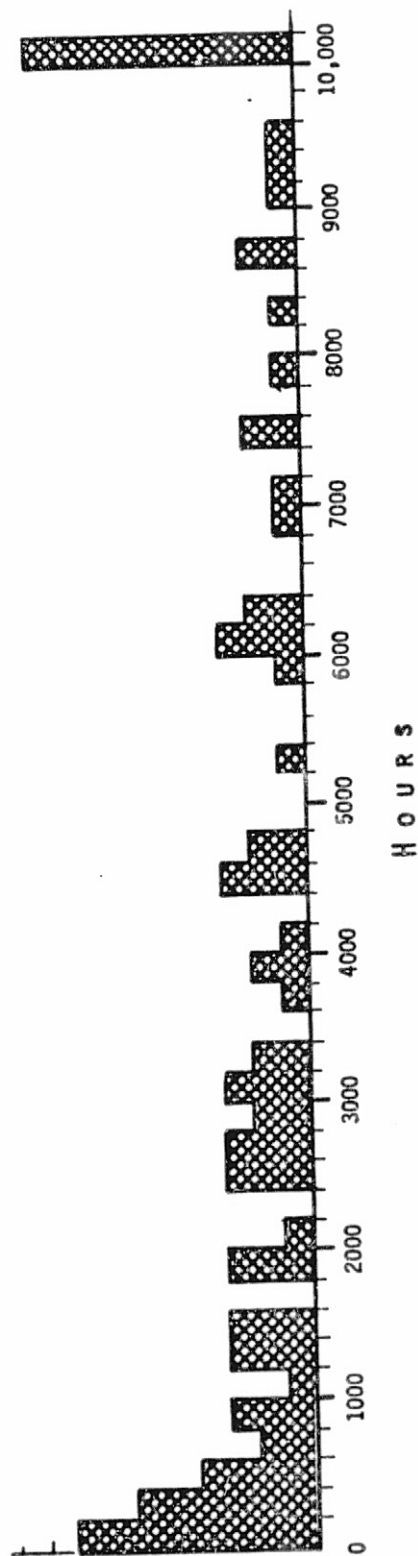
Figure 5-4.—Yaw Computer Failure Time Distribution

- b) Failure Rate Characteristics — figure 5-4.

Performance Anomaly ⁽¹⁾	33%
Failure/Warning Indication	20%
Fails BITE Test	20%
Inoperative	13%
Engage/Disengage Problem	0%
Other ⁽²⁾	13%

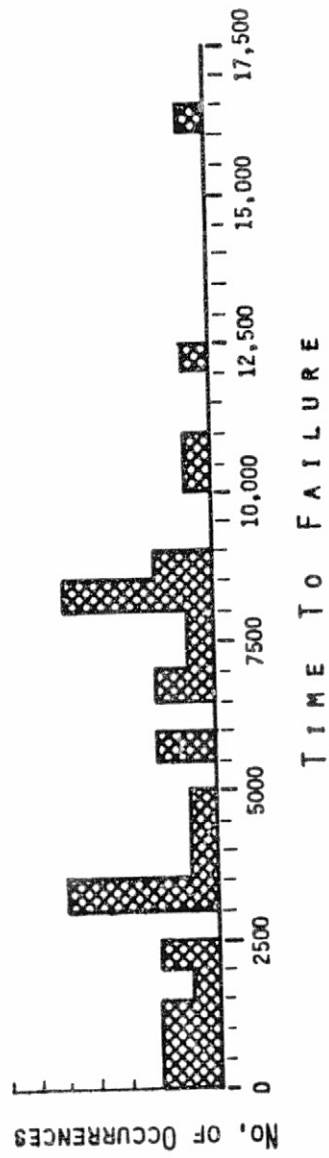
Figure 5-7.—Auto Throttle Computer Failure Time Distribution

181 failures/ 10^6 hrs
